High Arch Bridge: A Cost Benefit Analysis of Preservation Techniques as Applied to a Vernacular Concrete Structure

Ann Marie DiLucia
University of Pennsylvania

A THESIS

Historic Preservation

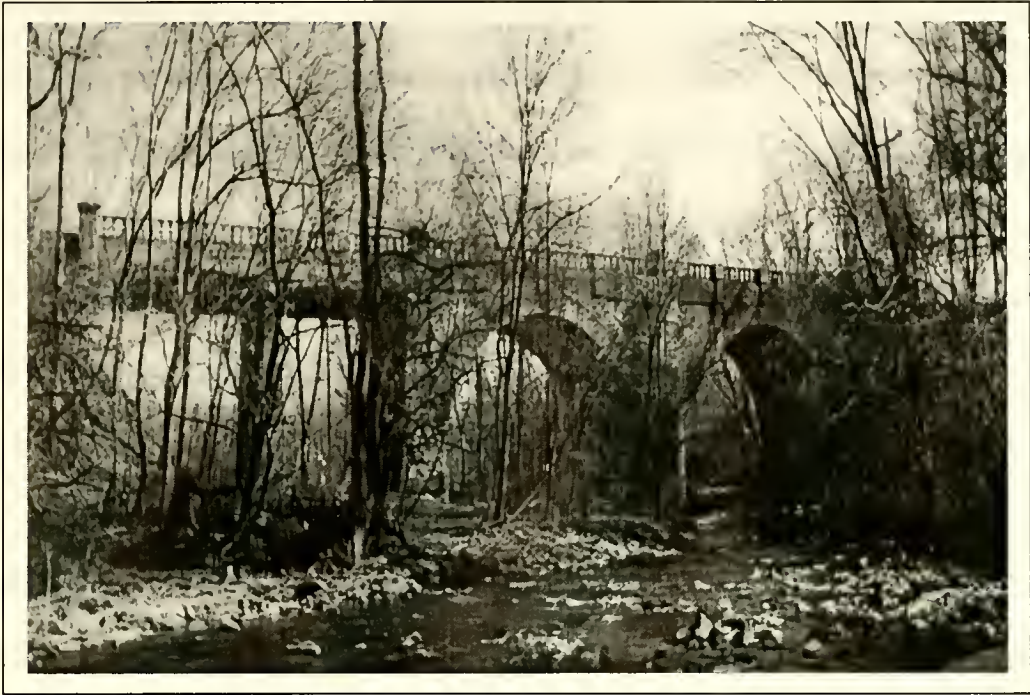
Observation of existing conditions reveals heavy losses of surface material, cracking, spalling, salt damage, and the effects of advanced freeze thaw cycling. The top portion of an abutment has crumbled away, and pieces of decorative elements lie in the creek below. Growth of a floodplain forest partially obscures view of the bridge from below, and vines have embedded themselves in another, still intact, abutment. Salt rings and water stains caused by drainage pipes cover the surface of the interior arches.

Figure 1 High Arch Bridge, west face.

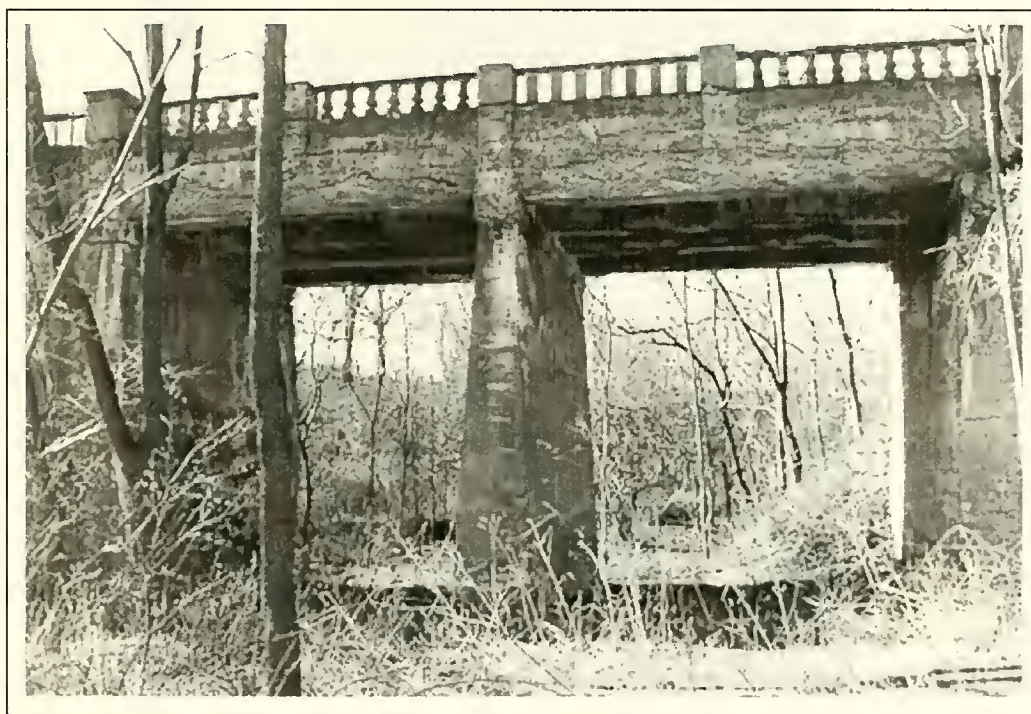
Figure 2 Straight spans, east face.

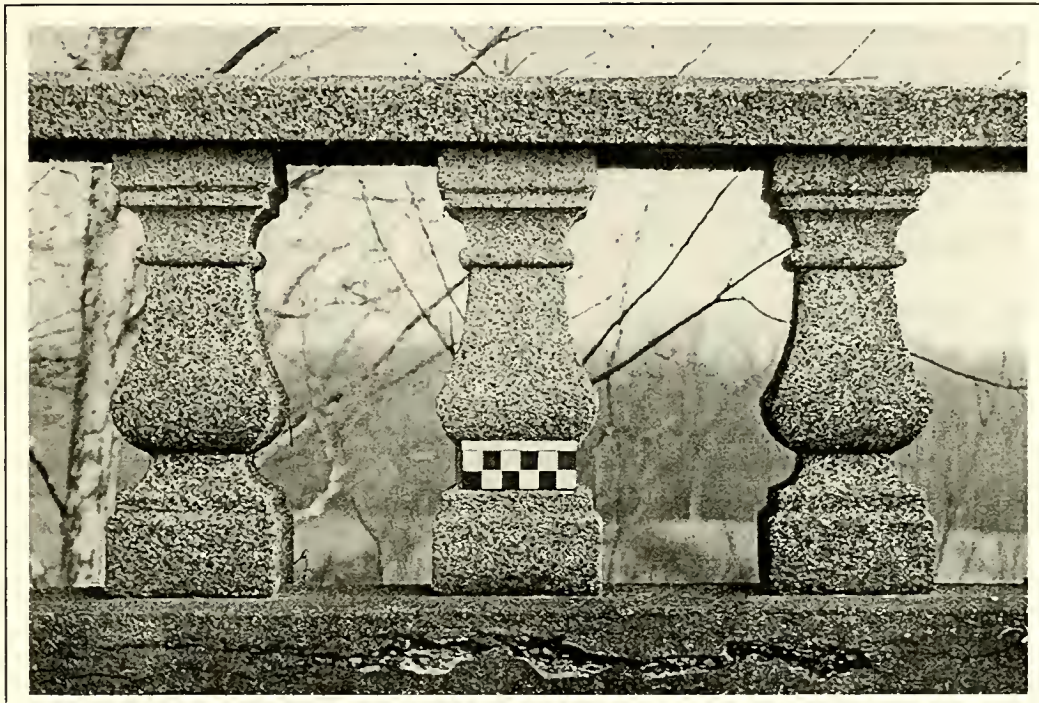
Figure 4 Balusters, east side of parapet.
